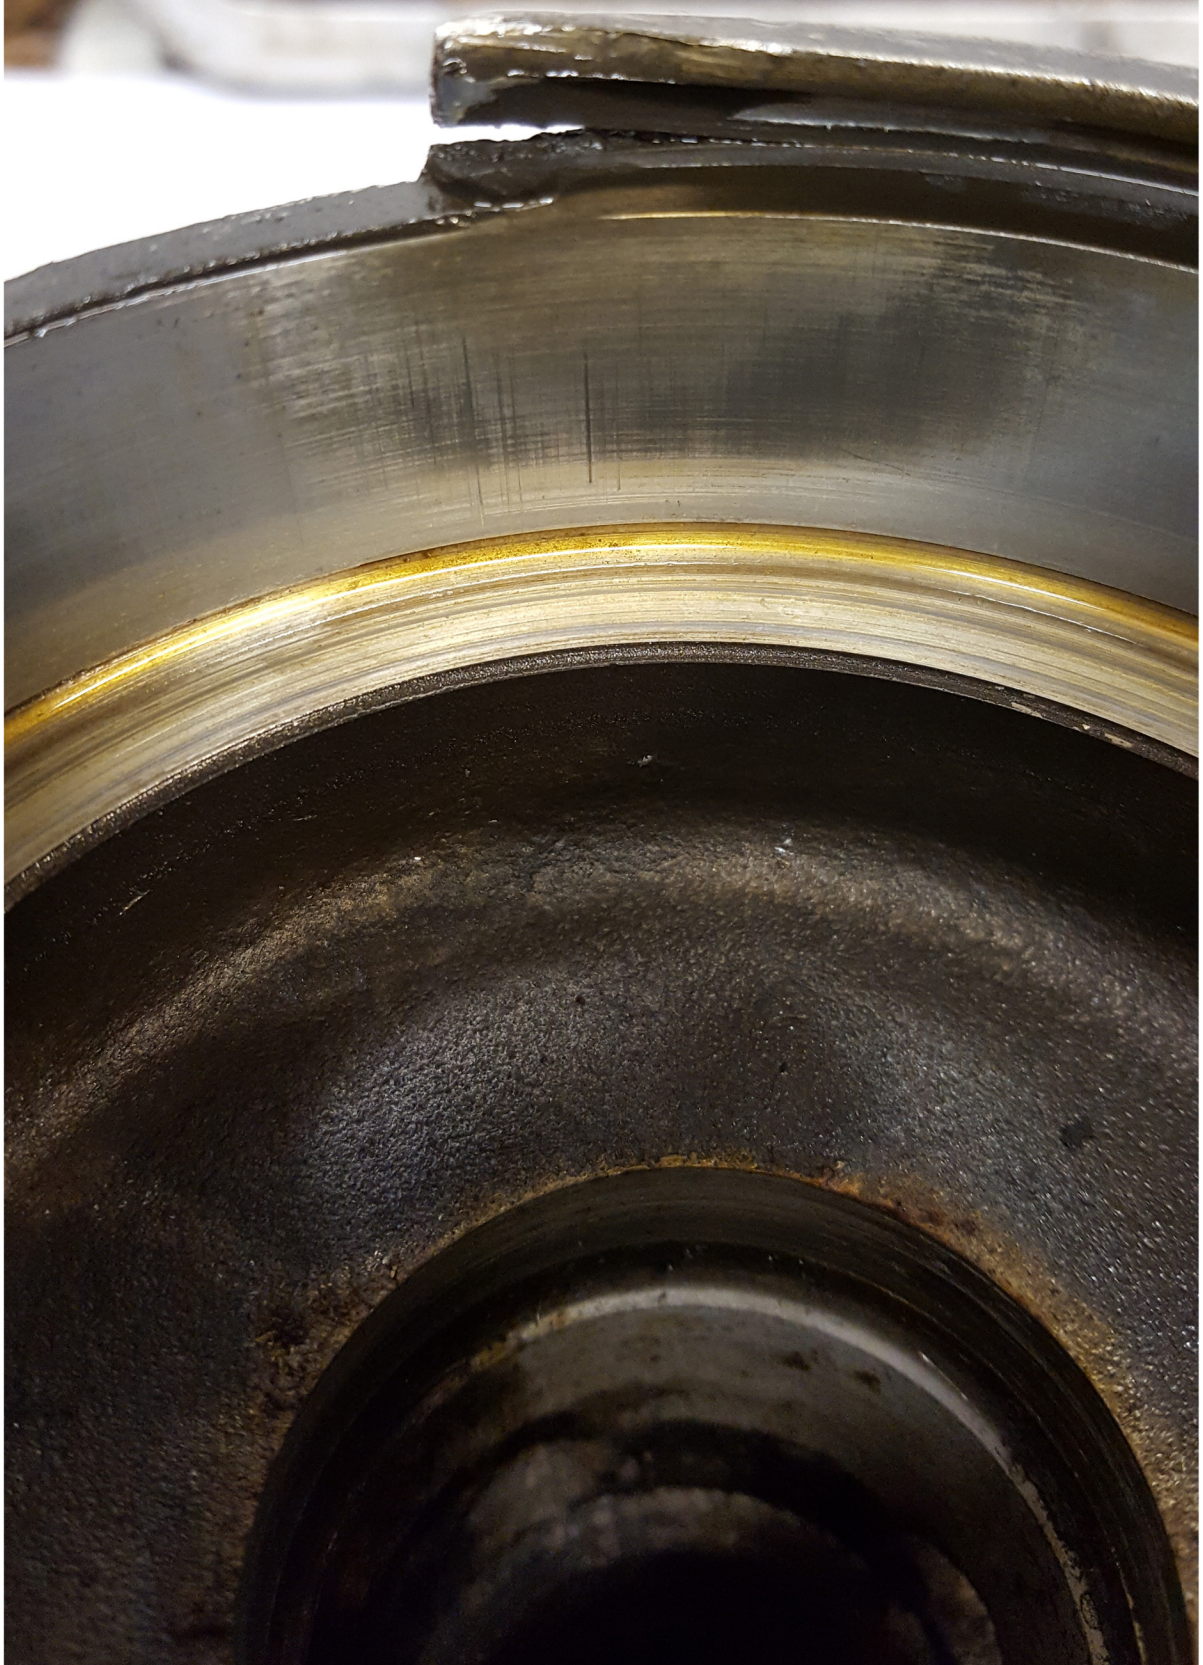
If a round-shouldered bearing is used,
the snap ring can move, causing the
lip in the housing to break as you can see here.
This can cause a full gearbox failure.
